Flying Empires

Short 'C' class Empire flying boats

Written by Brian Cassidy
3 Queen's Parade BATH BA1 2NJ UK.

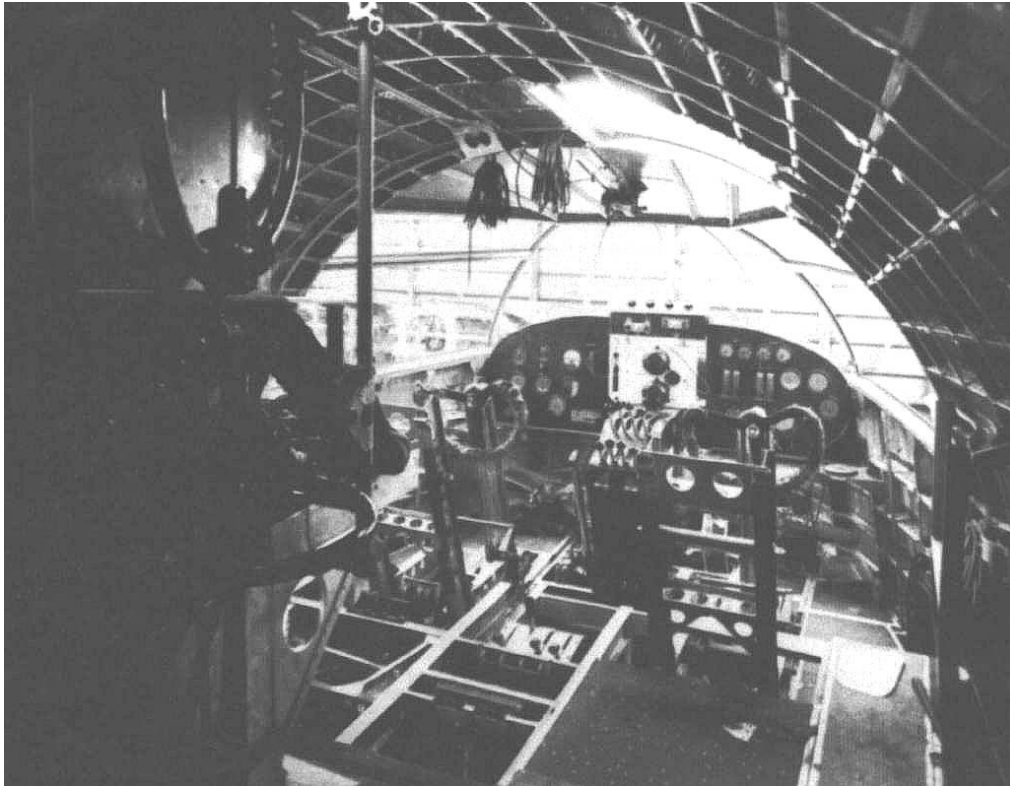
27. Short Bros. photo H 886. The uncompleted Control Deck of 'HL CANOPUS' showing the pilot's seats, the carburettor cocks between the seats and the trim tab controls on the roof of the coupé. The D/F loop is on the left of the photo. The observation hatch, behind the starboard pilot's seat, is without the cover with fold-out windscreen.

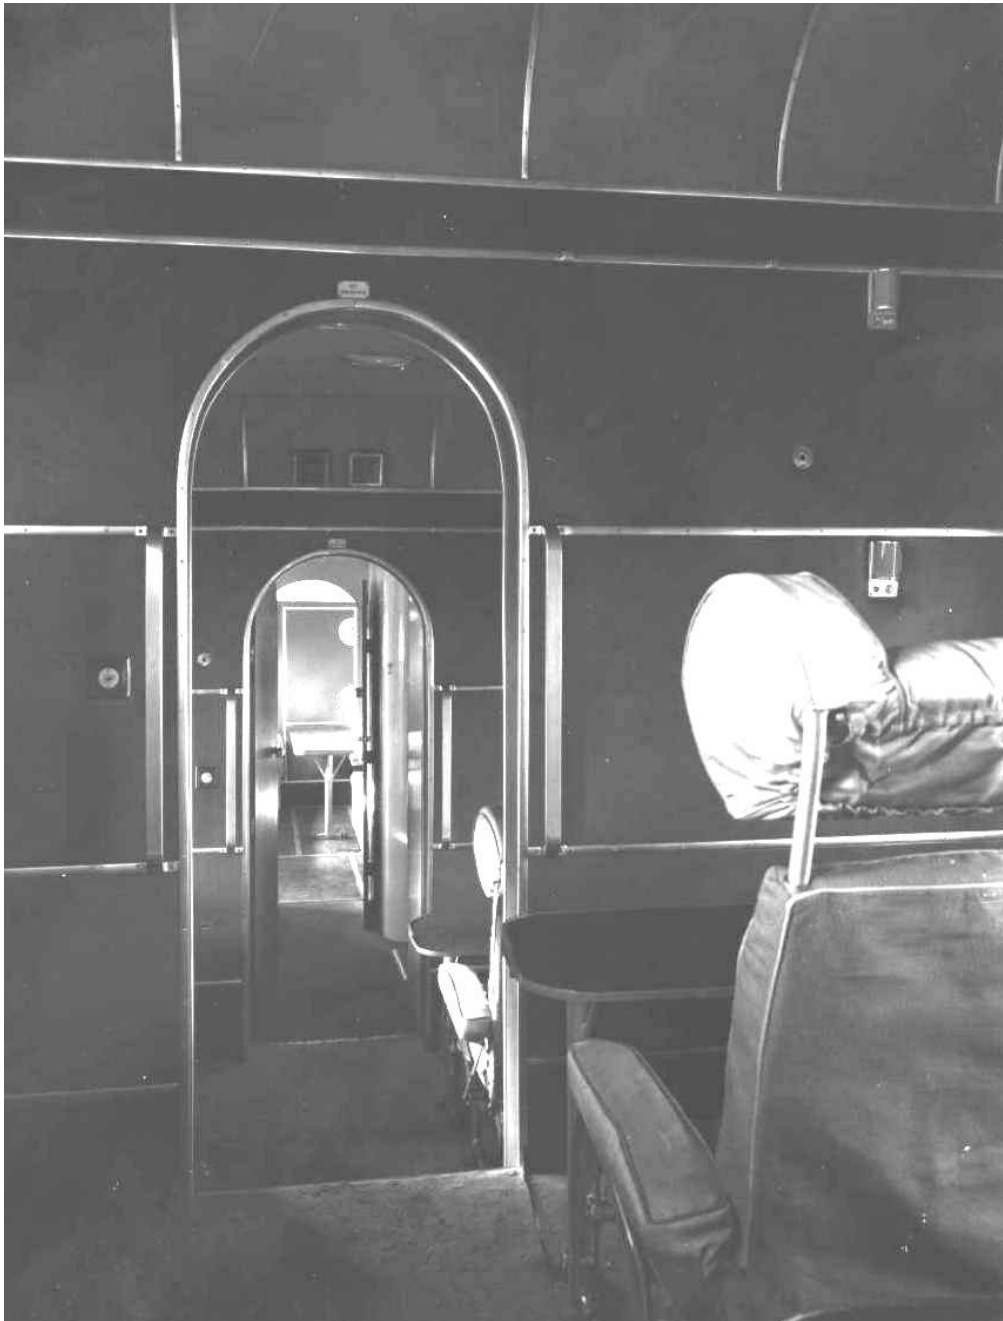
28. **Short Bros. photo H 939.** The photograph is taken in the Promenade Cabin looking forward, showing the Centre Cabin, the entry to the pantry and the Forward Cabin beyond.

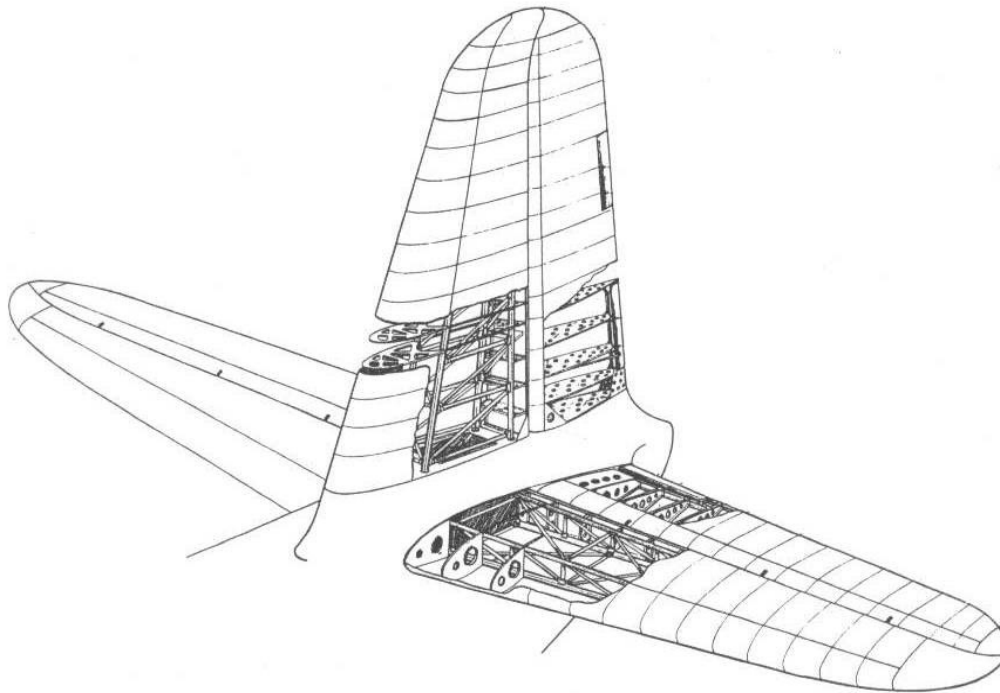
29. Maintenance Manual Diagram 50 showing the construction of the tail.

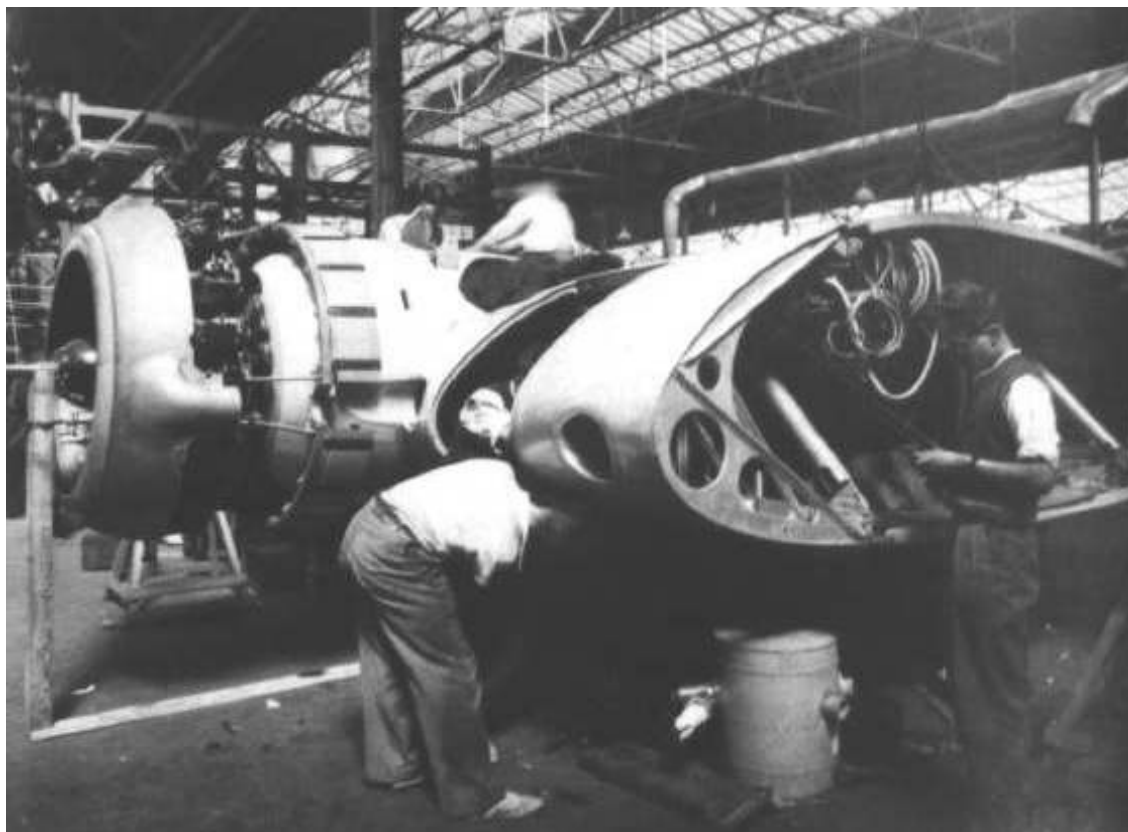
30. Short Bros. photo H 877 showing the starboard inner engine of 'HL CANOPUS' fixed in position on the nacelle, complete with collector ring and gills but without cowling or exhaust pipe.

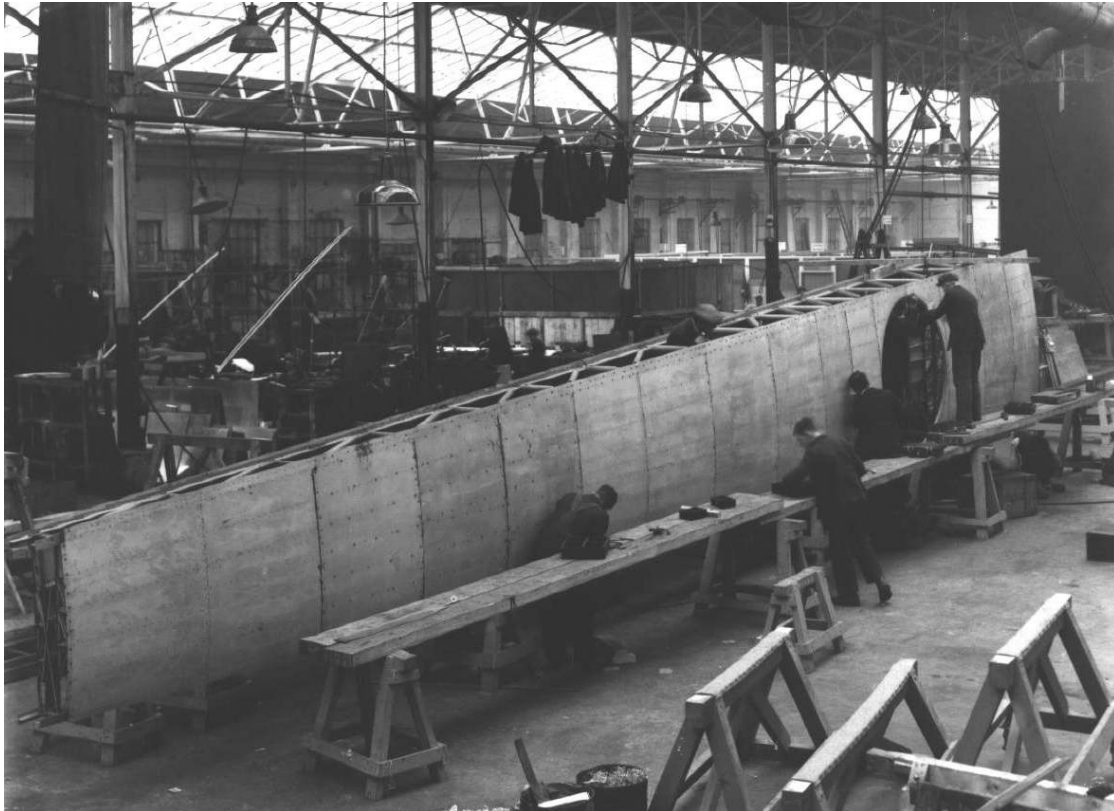
31. Short Bros. photo H 803 showing the starboard mainplane spar box of 'HL CANOPUS'. The assembly is tipped onto its leading edge as the sheeting between the spar booms is fixed. Most of the sheets are riveted, with three of them tack bolted. The rear spar boom is visible as are the top and bottom flanges protruding from the tip.

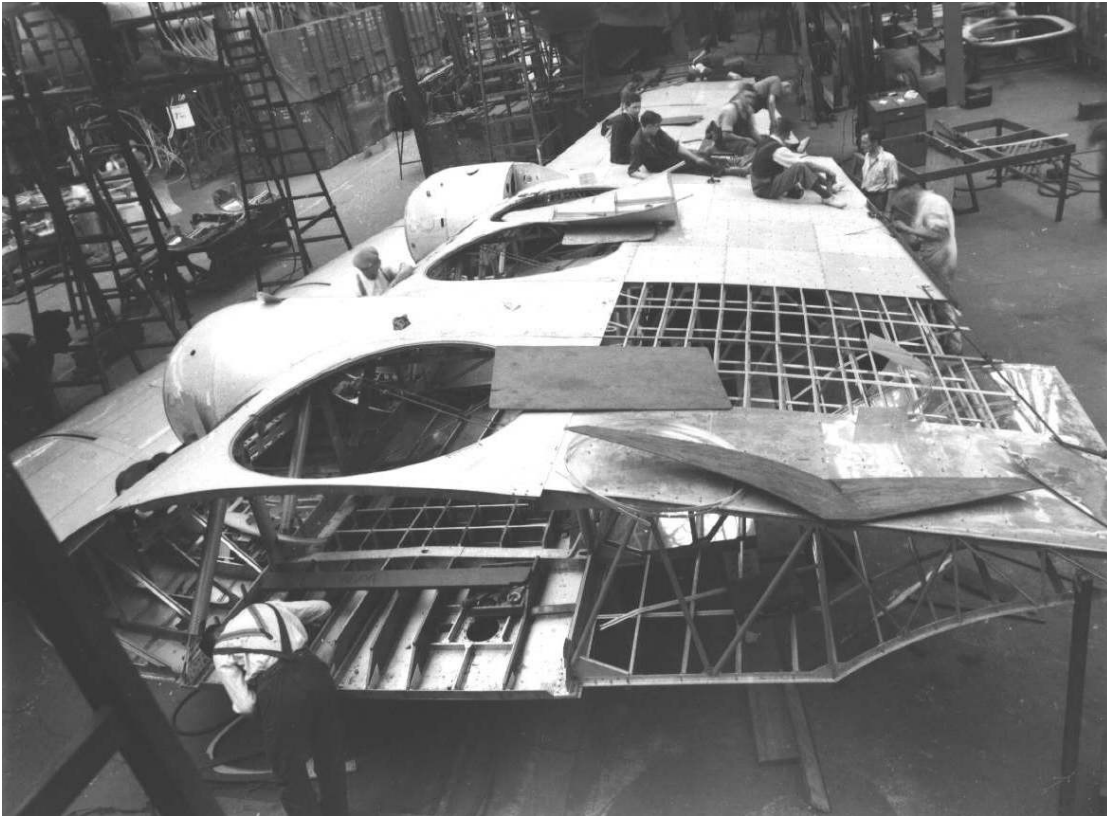
32. Short Bros. photo H 1086 showing work in progress on the starboard half mainplane of 'CV CARIBOU' - Part number SB 3501. A finished flap is evident below the leading edge.

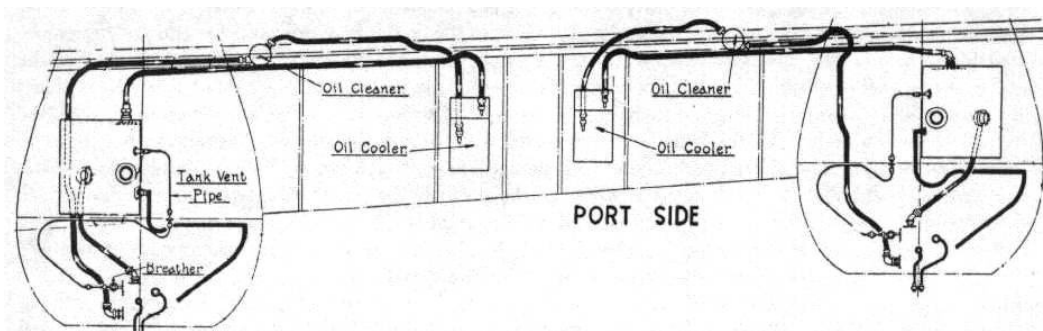
33. Part of Maintenance Manual Diagram 2 showing the oil system for a standard Mark I S.23 'boat perseus type oil coolers with the ducts similar to the starboard side of 'UI COORONG ...' - presumably RH5-43 coolers.

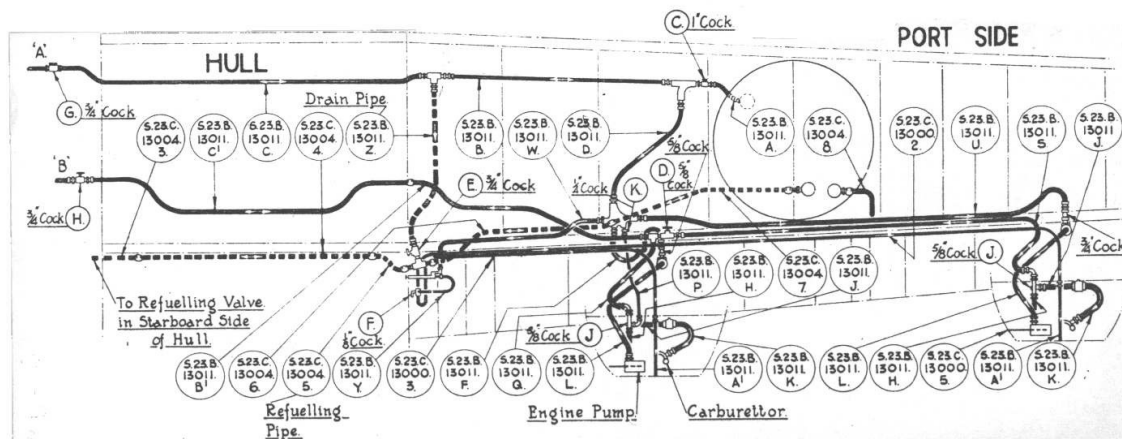
35. Part of Maintenance Manual Diagram 1 showing the fuel tank and associated pipework for a System 1/1D fuel system fitted to the standard Mark I S.23 'boats.

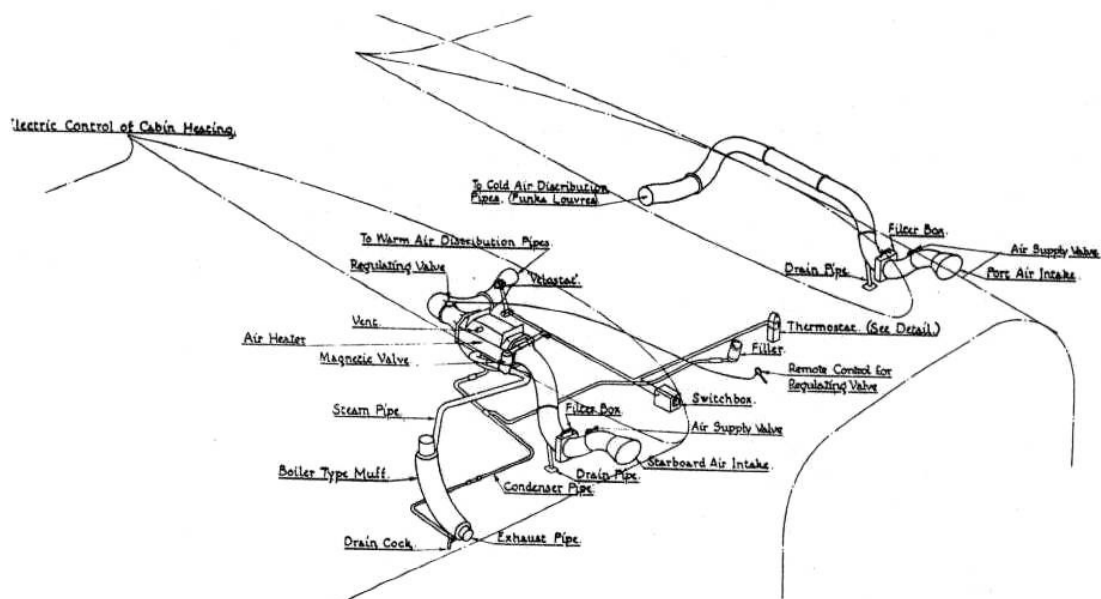
36. Part of Maintenance Manual Diagram 33 showing System 33 used the standard S.23 'boats.

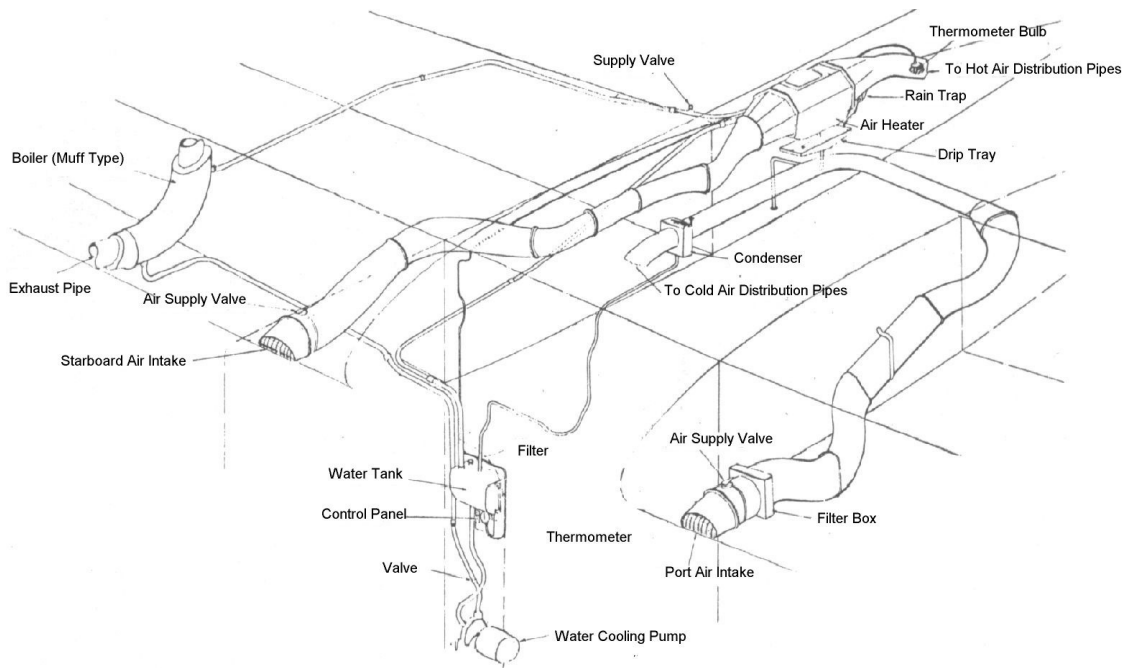
37. Part of Maintenance Manual Diagram M 33 showing System M33 used for the S.30 'passenger' boats - presumably all except 'CU CABOT and 'CV CARIBOU.

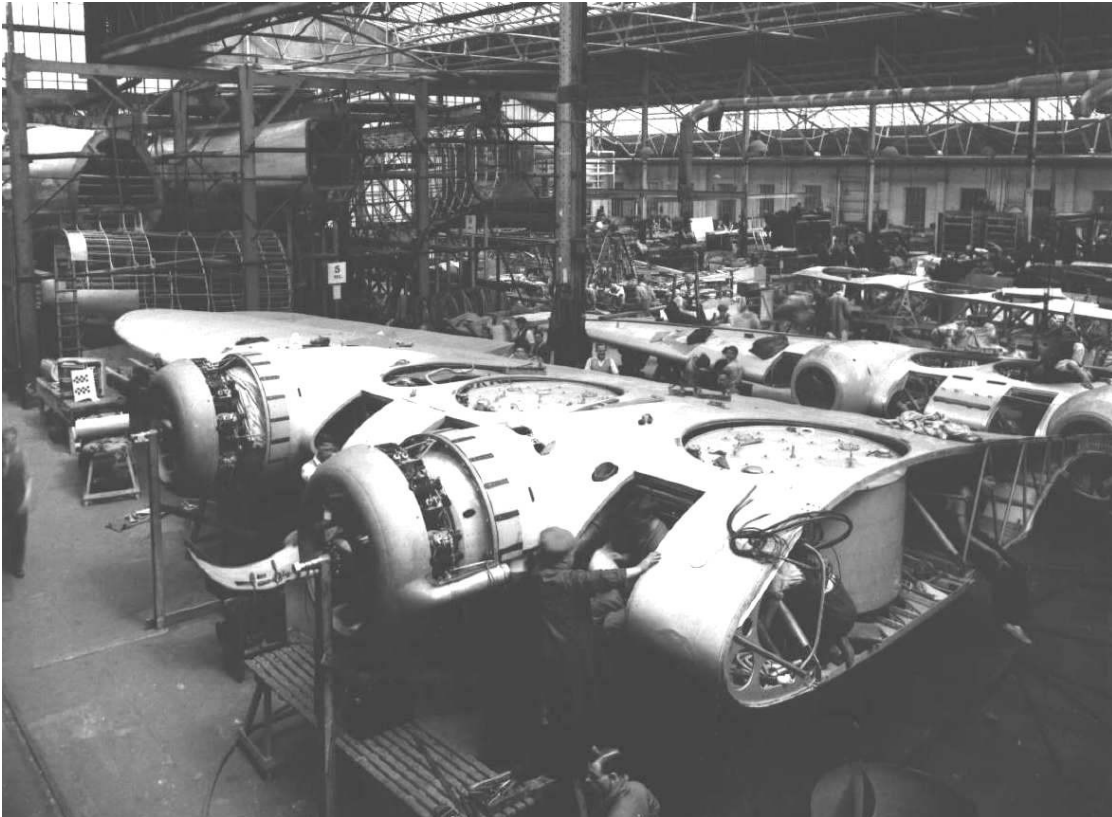
38 Short Bros photo H 917 showing the starboard half mainplane of 'HM CALEDONIA' practically ready for lifting for attachment to the hull. The starboard half mainplane of 'UT CENTAURUS' is next in the line, with the port half mainplane spar box of 'UT' behind it. In the gantries are, left to right, the hulls of the Sunderland prototype K 4774, 'UV CAMBRIA' and 'UZ CYGNUS'.

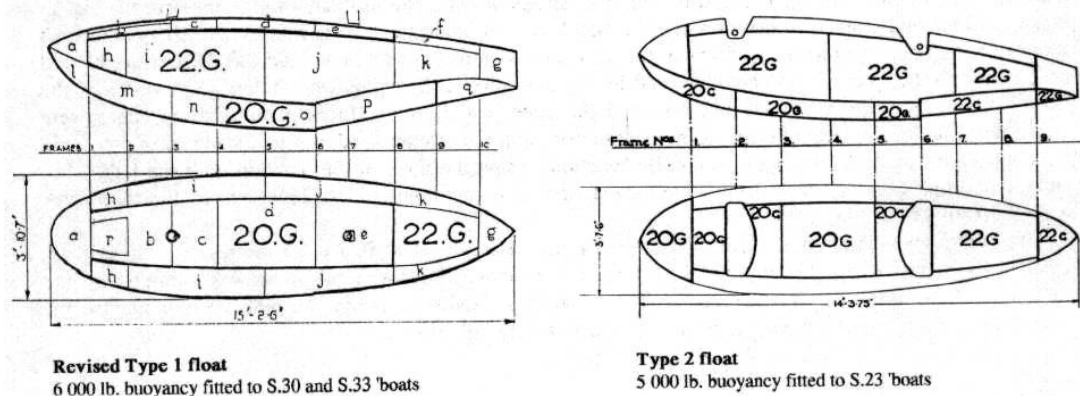
39. Parts of Maintenance Manual Diagrams 48 and M 48 showing the revised Type 1 and Type 2 floats.

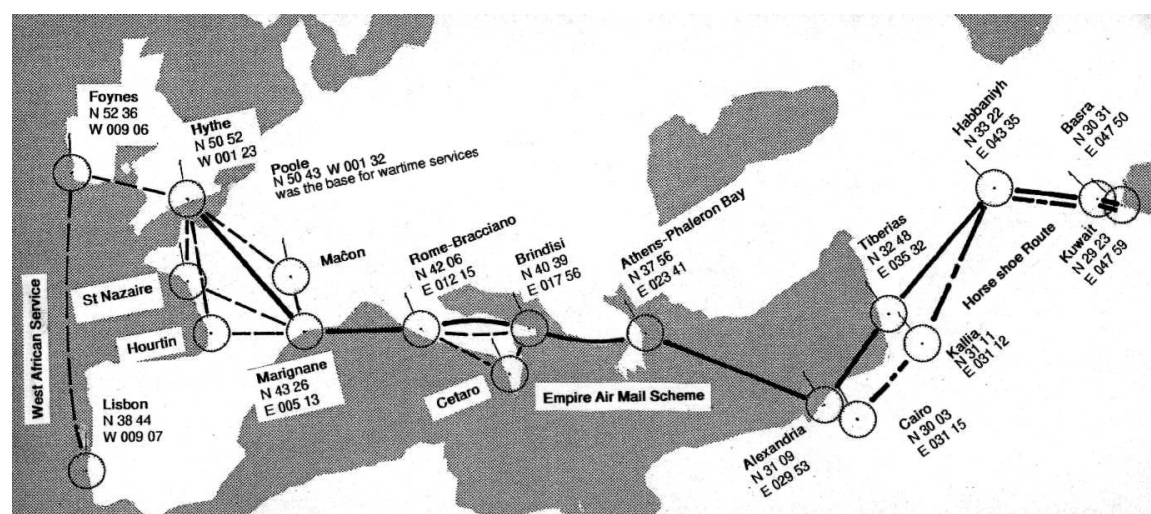
40. The Empire Air Mail Programme from the UK to Egypt.

The EAMS route started from Southampton Water, either at moorings off Hythe or from Berths 101 or 108 at the new Southampton docks. Four routes were used across France for the Southampton-Marignane sector depending on the weather conditions, actual or forecast.

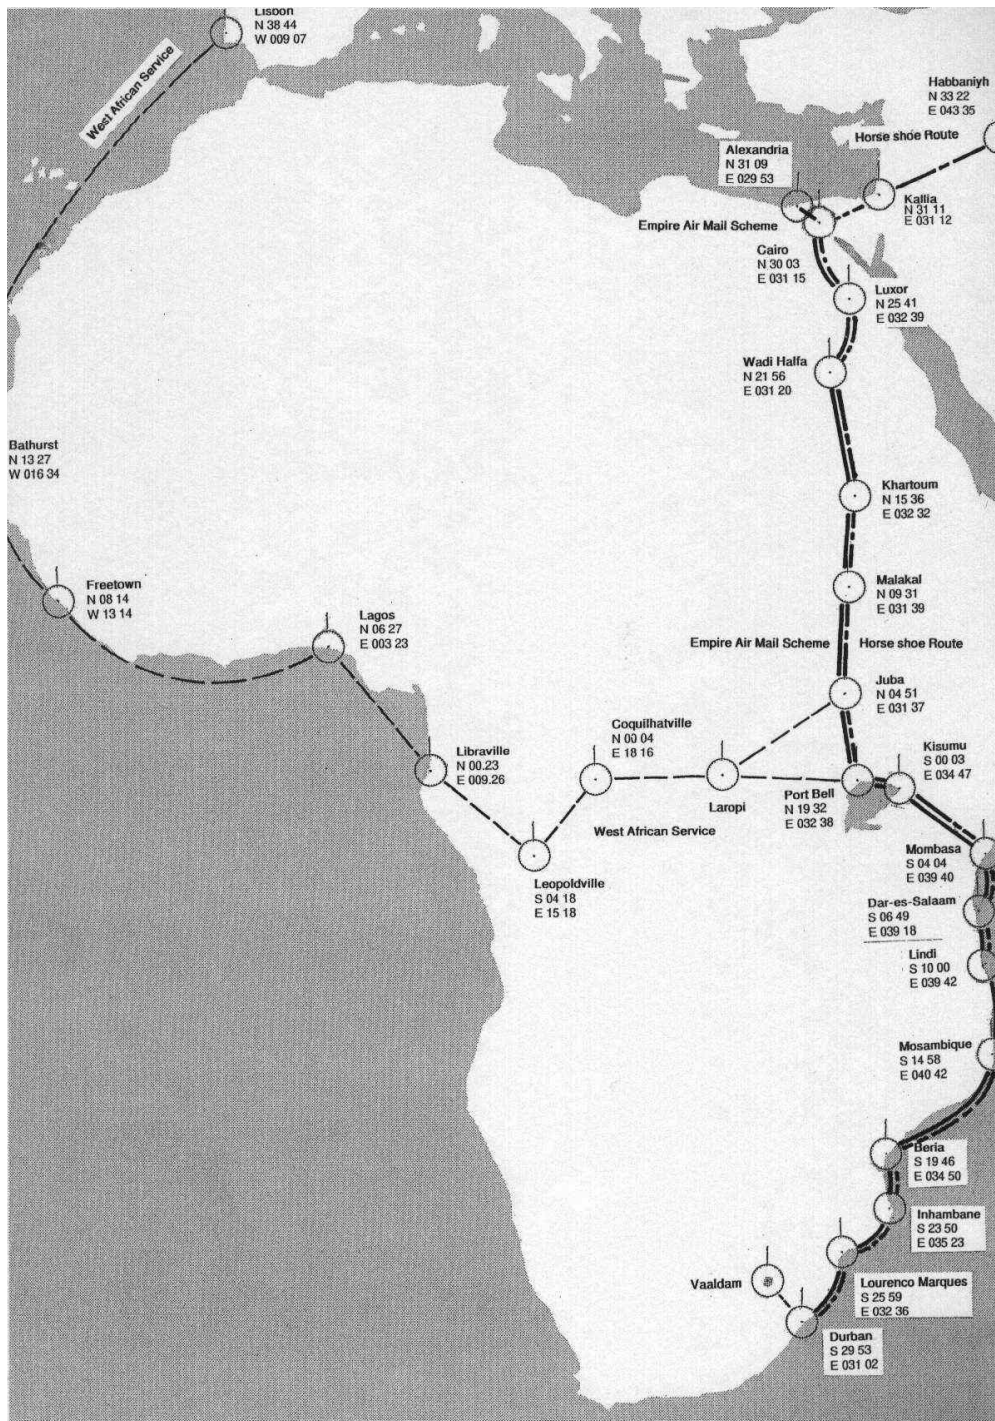
41. The Empire Air Mail Programme, the Horseshoe Route and the West African Service.

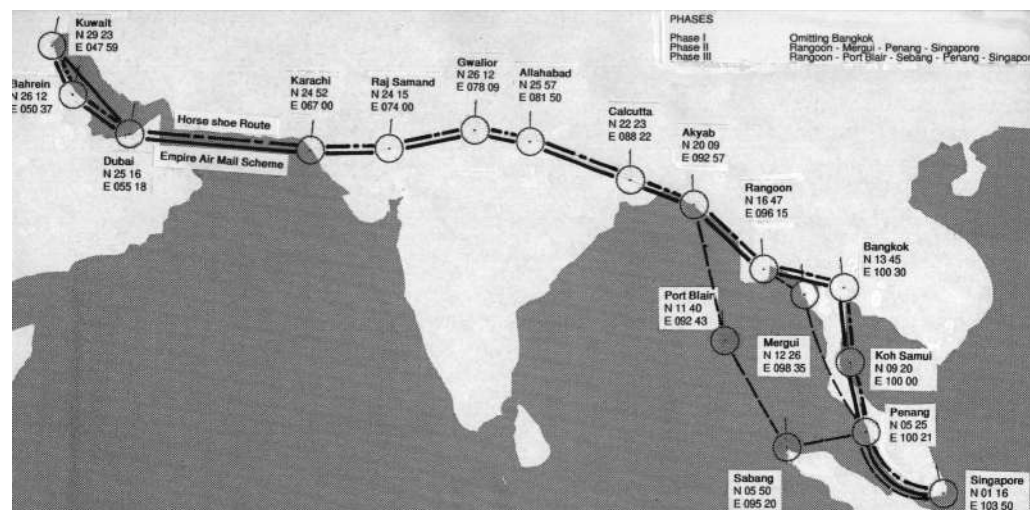
42. The Empire Air Mail Programme and Horseshoe Route

Akyab was an optional refuelling point. IAL passengers used the shallow-draught vessel *Tanko* as a lounge while the aircraft was refuelled. The sector to Rangoon was flown down the west coast of Burma and thence across land and the Dawna mountain range to the alighting area 16 km. north of the city - a distance of 274 n.m. or 504 km. The giant Shwe-Dagon pagoda, covered with gold leaf, was clearly visible 16 n.m. (30 km.) away and the 'boats flew low over the pagoda to give the passengers a good view.

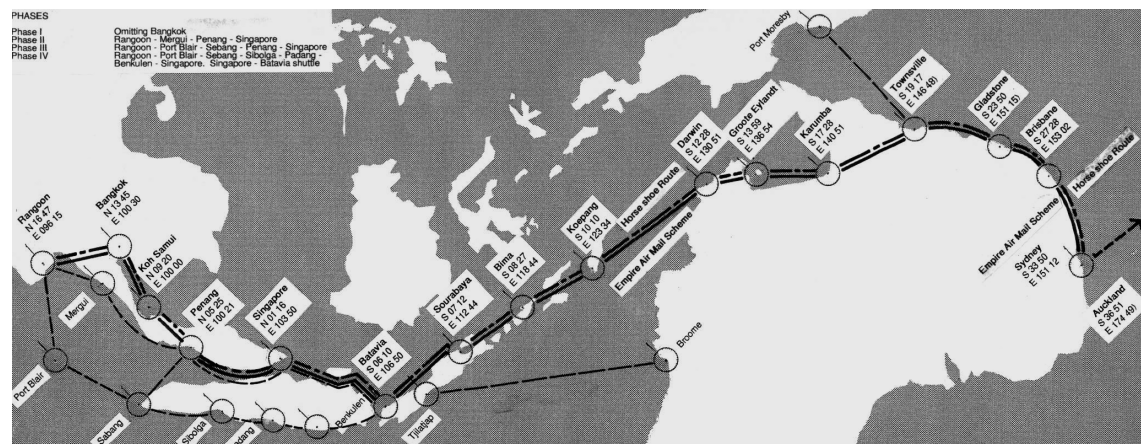
43. The Empire Air Mail Programme and the Horseshoe Route

The next 494 n.m. or 909 km. sector across the Sea to Darwin was flown at 10 000 ft to avoid the south-east prevailing winds in winter, to alight on the harbour with its tidal range of 8 metres. The cyclone season was from December to March. British Power Boats built a special patrol and rescue launch for this sector capable of 27 knots at full throttle, to be stationed at Darwin. The launch could rescue up to 50 persons unlucky enough to ditch in the 'shark infested' Timor Sea. The eighth night stop was spent at Darwin Cottage.

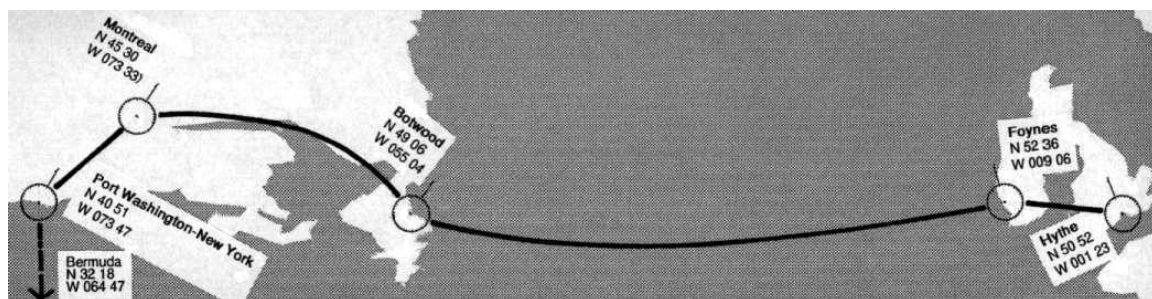
44. The Trans-Atlantic Service.

The object of the survey was to discover the timing and extent of the best and worst weather conditions likely to be met by an aircraft flying the various routes across the North Atlantic. Theoretical schedules were prepared using information from the charts, indicating the limits within which flight durations might fall. Allowance was made for head and tail winds, and deviations to fly over, under or round storm centres. The schedule for the Foynes-Botwood sector showed a worst case flight duration of 23 hrs. 30 min. and a best case flight of 10 hrs., based on a theoretical average speed of 130 knots (240km. per hr.). During the most favourable months - April to September - the east-to-west crossing time was calculated to be 14 hr. 30 min. increased, between October and January, by an hour. The five-year average case showed that there could be periods in December, January and March when crossings of between 10 hr. and 10 hr. 30 min. would be possible. IAL had three aircraft already stationed in Newfoundland, two de Havilland Fox Moths - VO-ABC and VO-ADE - and a Fairchild 71 - VO-AFG - and they were used to investigate upper air conditions over Newfoundland. Fog was a persistent problem in the St.John's area but less so at Botwood.
